# Manase Beach Replenishment Savai'i, Samoa

Samoa Tourism Authority.

Tonkin + Taylor International (T+TI) was commissioned by the Samoa Tourism Authority to assess options for shoreline protection for Manase Beach, to carry out preliminary design and develop an implementation plan for the best and most practical solution.

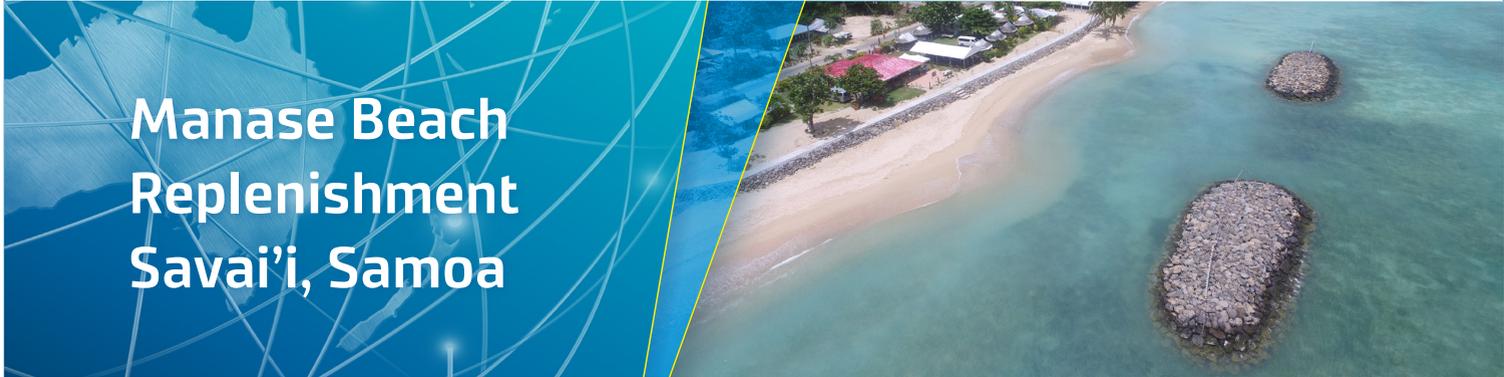
Two low crested, emergent breakwaters were built to maintain a beach in front of Vacations and Regina's Beach Fales. Each is 35m long (25m at the water level) and located some 50m offshore. These increase wave sheltering and modify the wave direction to shore, reducing sediment losses offshore and alongshore.

To address coastal erosion in the short-term, beach replenishment along 170 m of eastern Manase Beach using 2000 cubic metres of externally-sourced sand was proposed, along with control structures to maintain sand position and limit migration out of the replenishment area.
